Manhole Inspection Summary

Manhole # S53O__043MH

Location Address: **3200 toone street**

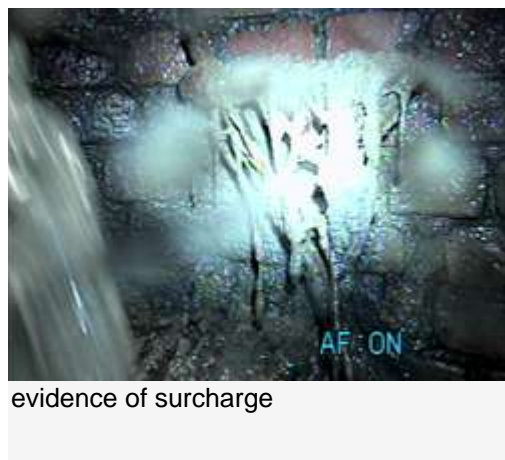
Defect 6

Surcharge ☒ Evidence Of Surcharge Depth: **9** (ft.) ☒ Active Surcharge Present

evidence of surcharge

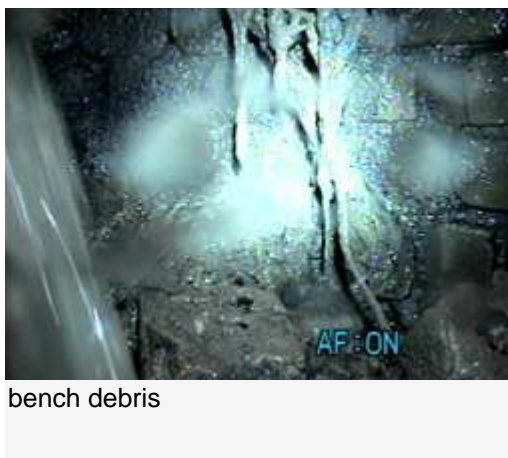
Defect 5

Condition: ☐ Sound ☐ Cracked ☐ Root Intrusion ☐ Deteriorated ☐ Leaks ☒ Debris

bench debris

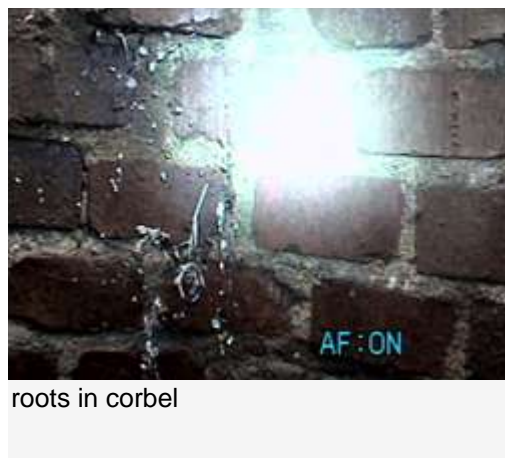
Defect 4

Condition: ☐ Sound ☐ Cracked ☒ Root Intrusion ☒ Loose Brick ☒ Deteriorated

roots in corbel

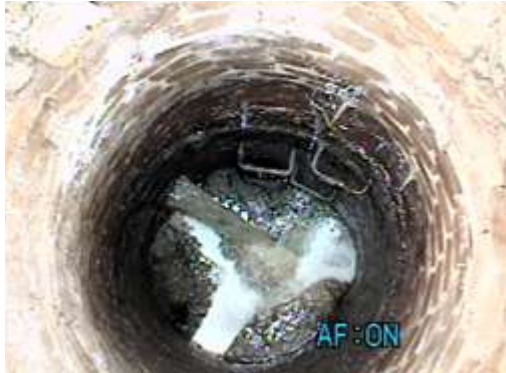
Defect 3

Steps Count: **6** Missing: **2** ☒ Corroded

missing steps

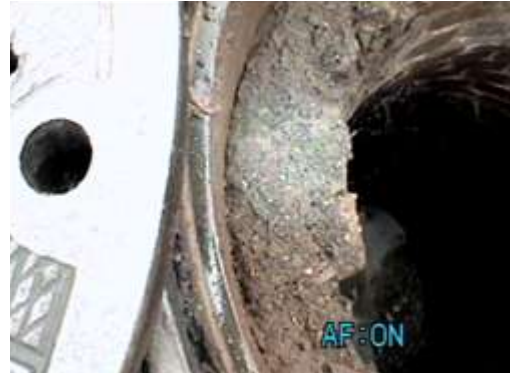
Defect 2

Frame Offset: **6** (in.) Condition: ☒ Sound ☐ Cracked ☐ Leaks

offset

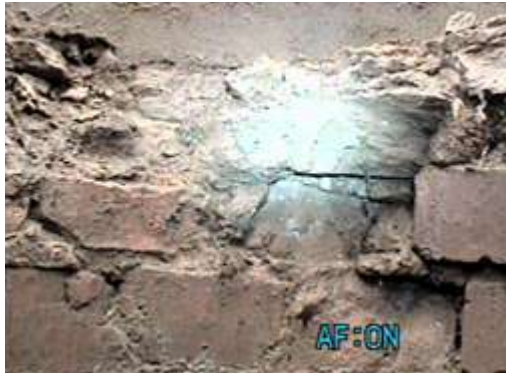
Defect 1

frame adj loose bricks, deteriorated

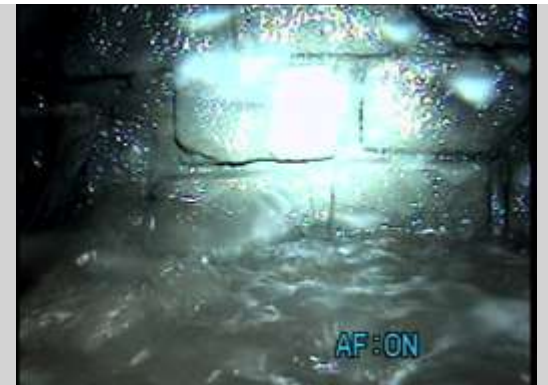
3 O'Clock Inflow

most of pipe under water

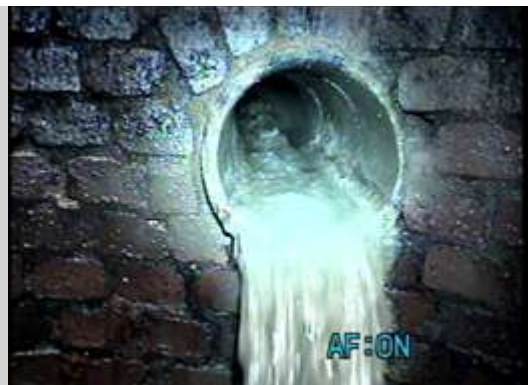
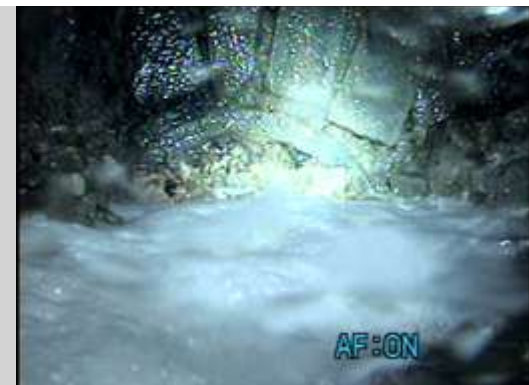
6 O'Clock Inflow

Comments **Only top of Pipe at 6 is above water**

Drop Condition: **Partly Clogged**
